Submission on Notified Proposal for Plan, Change or Variation

SCHED 3-4 - Schedules of Historic Heritage Chapter - variation/addition

ST PETER'S ANGLICAN CHURCH
2 DYSON STREET,
TEMUKA

May 2021

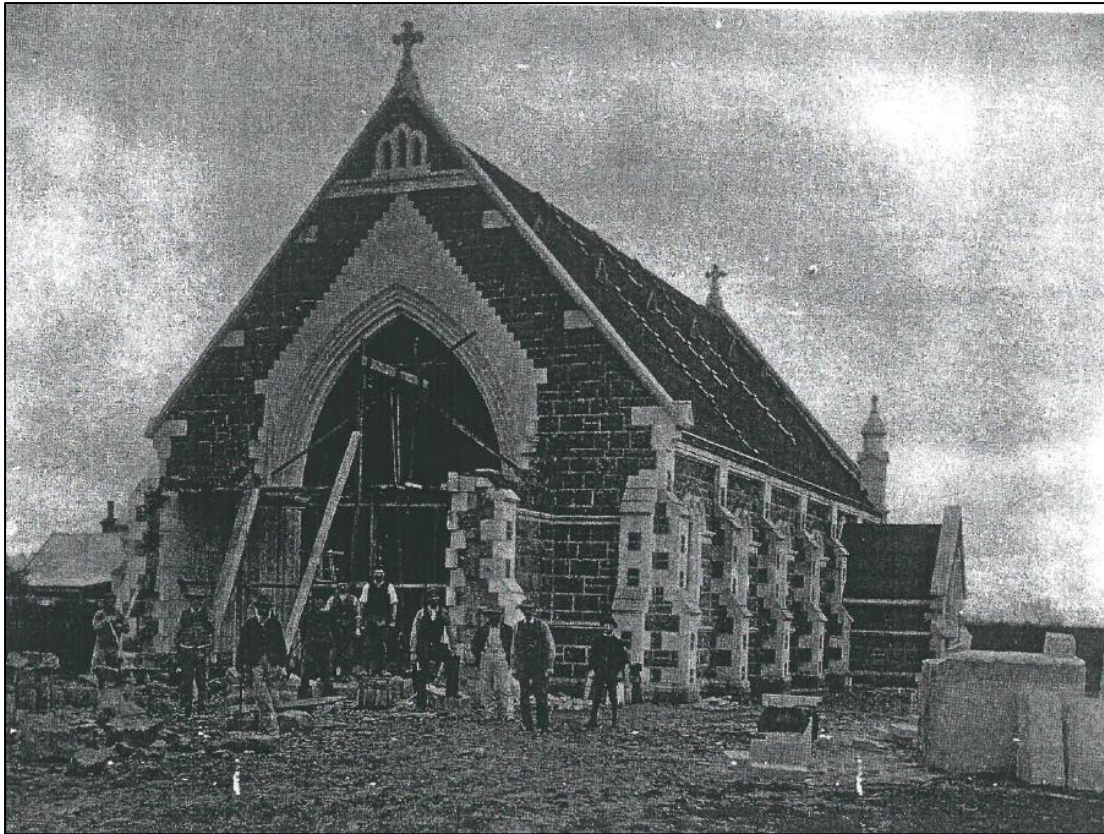
*View of St Peter's Church under construction. John Langridge is pictured with walking stick alongside other working men, all of whom stand in front of the chancel arch at the east end of the church. Source: Sheila Langridge, *From Sussex to Canterbury: the story of the Langridge family*, 1999, p33.*

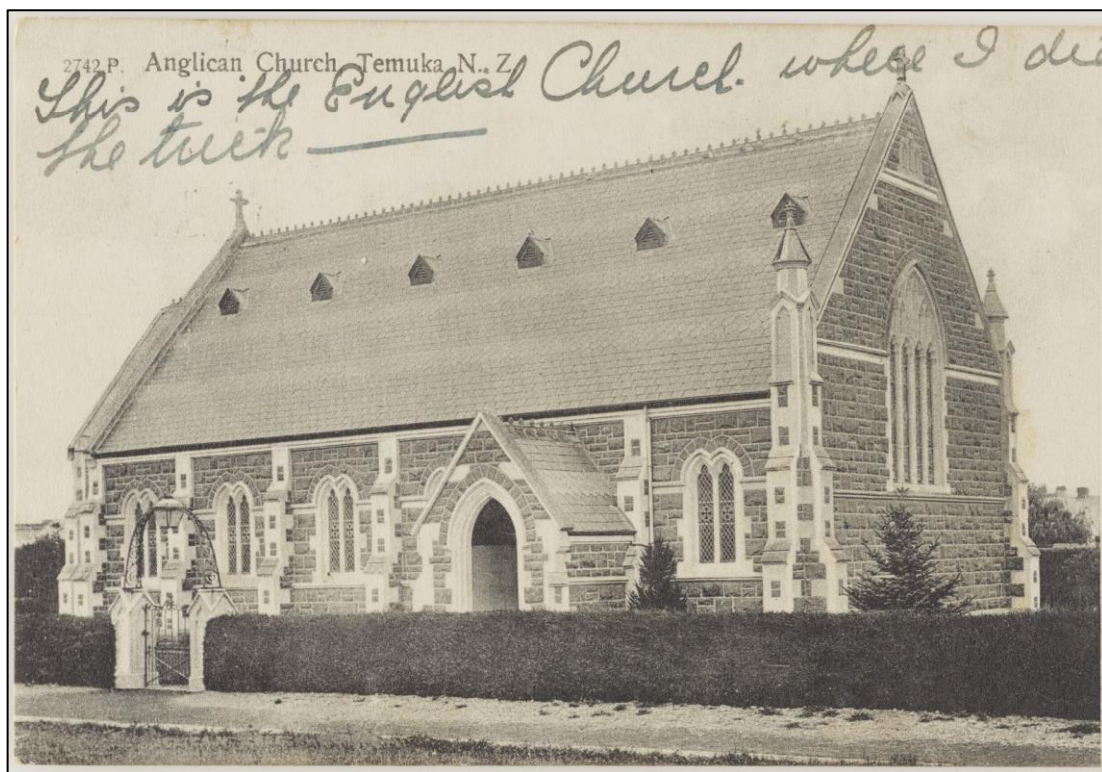
1907 postcard of St Peter's Church, Temuka. Note the original concrete Gothic posts and steel gate, now removed. Source: Muir & Moodie Studio.

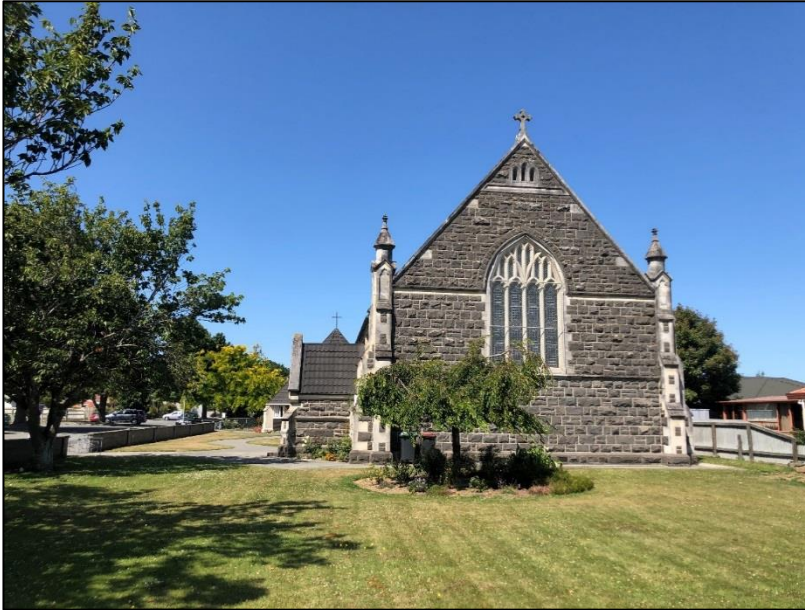
The prominent west gable end facing King Street is surmounted with a stone cross and framed on either side by polychromatic stepped buttresses capped with domed pinnacles extending beyond the roofline. The gable end features a single arched tracery window with a wire mesh screen placed over the stained glass.

West elevation of church facing King Street. Source: DPA Architects, January 2020.

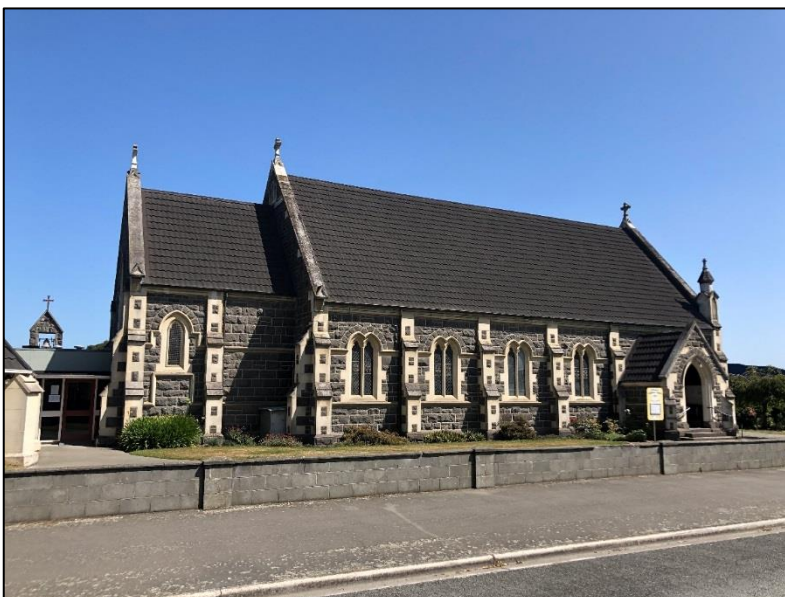
The chancel is located at the east end of the nave and is composed of two bays with a single lancet window in the eastern bay. The chancel features a similar pitched, albeit lowered, roofline from the nave. Stone crosses surmount the east and west gable ends of the nave and the east gable end of the chancel. The original blue and green slate tiled roof with its series of gabled roof vents and decorative ridge tiles as seen in the photograph on page 12 has been replaced with the existing metal tile cladding with painted stone chip finish.

North elevation of church facing Dyson Street showing the gabled entry porch to the western end and the chancel with a lowered roof line to the eastern end. Source: DPA Architects, January 2020.

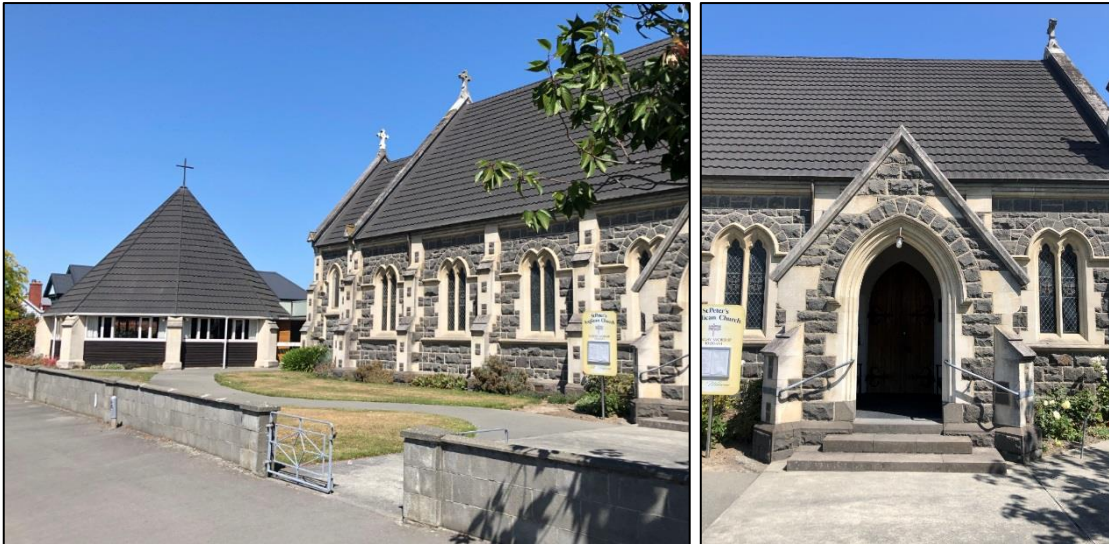
Left: North elevation of church with 1978 octagonal Parish hall at eastern end. Right: entry porch to nave. Source: DPA Architects, January 2020.

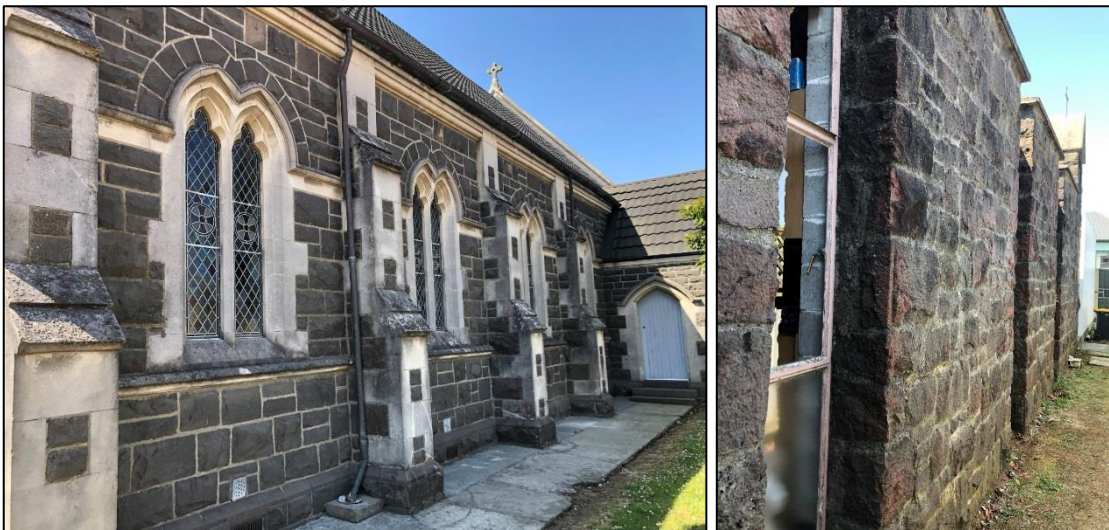
On the eastern end of the south elevation is the sacristy, accessed via an arched vertical tongue and groove timber clad door in its west elevation. Adjoining the sacristy from its east end, is the 1965 addition of the choir vestry and 1972 bell tower.

South elevation of church showing original church building with doorway to sacristy at left and 1960s addition of the vestry at right with bell tower seen at far right. Source: DPA Architects, January 2020.

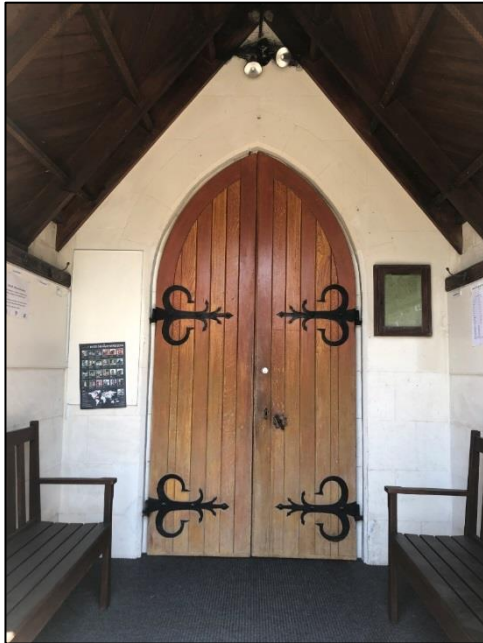
The nave is accessed via the gabled entry porch on the north elevation. The porch features carpeted floors, limestone walls and a stained timber ceiling comprising tongue and groove sarking over rafters and purlins. The pointed arched double entry doors feature vertical timber panelling with large ornate wrought iron hinges and has been modified to open outwards.

View within entry porch.

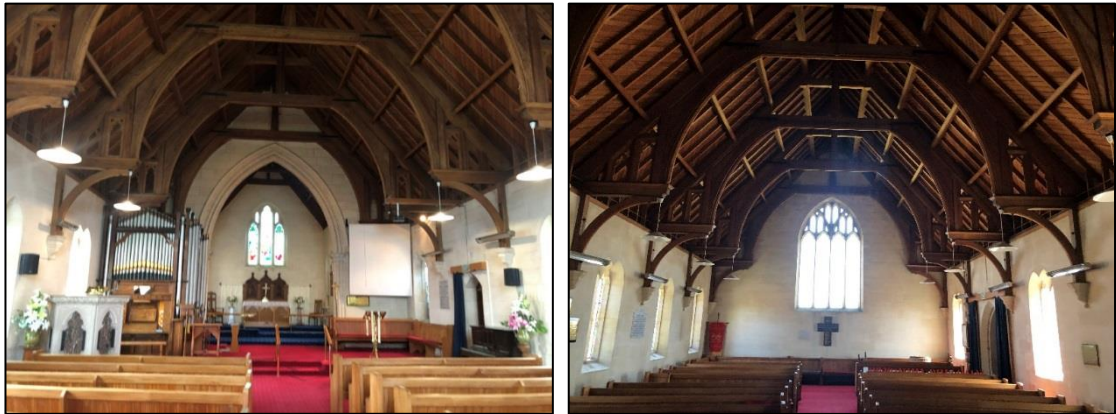
Steps with timber and brass handrails at the east end of the nave lead up towards the chancel, the entrance of which is framed by a large limestone arch with moulded columns and capitals.

Left: View east down aisle of nave toward the chancel. Right: View west from the chancel toward the rear wall of the church facing King Street. Source: DPA Architects, January 2020.

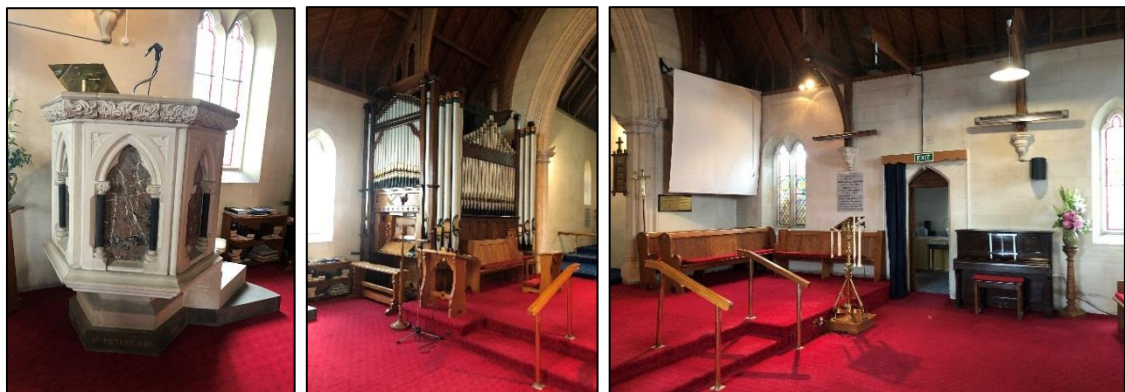
Left: White stone pulpit at northeast corner of nave. Centre: Pipe organ. Right: View of south corner of nave and adjacent doorway to sacristy. Source: DPA Architects, January 2020.

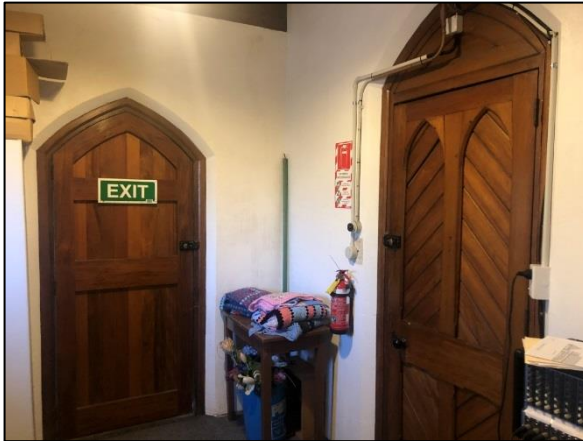
The sacristy is located off the south wall of the nave, at the eastern end and is accessed via a rimu panelled door. The sacristy features white limestone walls with tongue and groove rimu ceiling, carpet tiled floors and a sink bench and cupboards on the south wall. The single exterior window to the south elevation features reeded glass, while a tongue and groove rimu panelled door with cedar styles is located within the east elevation of the sacristy, leading into the 1965 vestry addition.

Interior of sacristy with door to church at right and exterior door at left. Source: DPA Architects, January 2020.

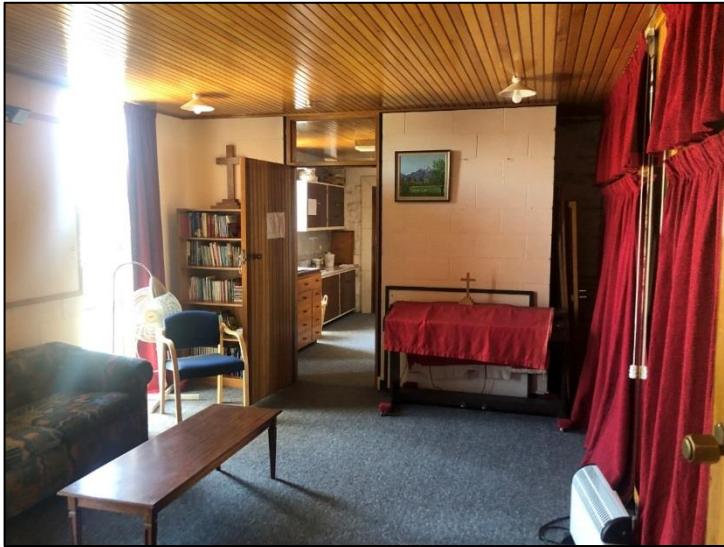
The choir vestry has painted concrete block walls and tongue and groove cupboards with curtains. A door matching the sacristy/clergy vestry door is located on the east wall of the choir vestry and leads into the toilet area.

View from northeast corner of choir vestry toward clergy vestry. Source: DPA Architects, January 2020.

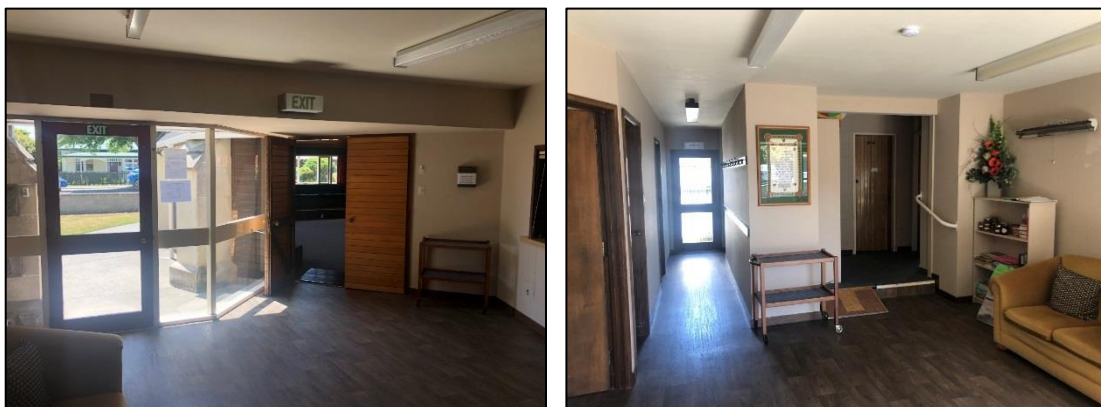
The entrance lobby has a plaster board walls and ceiling with vinyl tiled floors over concrete. The space has timber glazed doors and sidelights with timber trim and architraves to doors. Services include heaters and fluorescent lighting. The adjoining corridor features stained timber architraves and skirting, plaster board walls and ceiling and vinyl tiled floors.

Left: View of entrance lobby from vestibule. Right View of corridor at left leading to south toilet entrance at end, and vestibule leading to north toilet and vestry to the right of the image. Source: DPA Architects. January 2020.

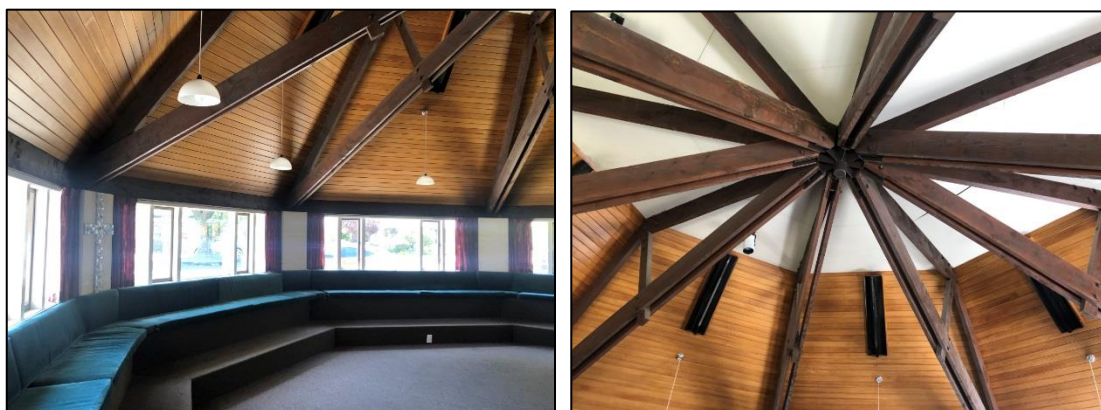
The parish hall is an octagonal space with stained timber trusses fixed at their apex with a steel bracket, tongue and groove timber lining to the lower portion of the ceiling and plasterboard lining to the upper portion. Concrete floors are overlaid with carpet and raised seating has been built into the space. The hall features timber window joinery with limestone piers between and tongue and groove rimu doors with cedar stiles and rails. Services include heater units, suspended lights and spotlights.

Left: View within parish hall showing raised built in seating. Right: Stained timber roof trusses with tongue and groove panelling to lower portion and plasterboard above. Source: DPA Architects. January 2020.

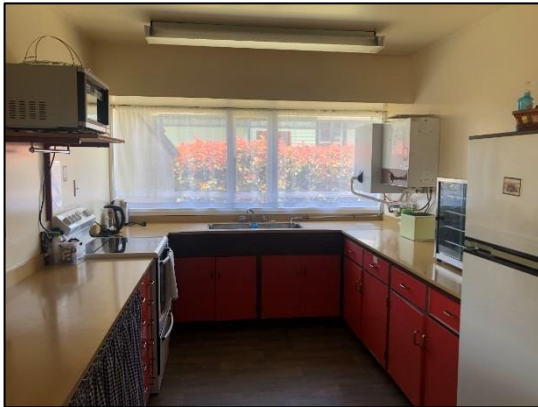
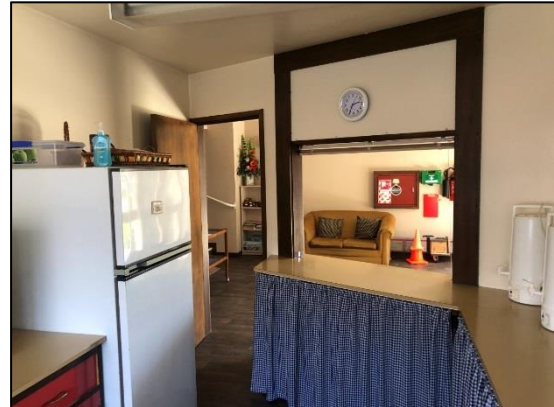
Adjoining the hall is a kitchen, with plaster board walls and ceiling and vinyl floors. The kitchen has built in cabinets with laminated bench tops, a hollow core door with stained timber architraves and an adjacent servery, with similarly stained timber frame.

Left: View of kitchen from entrance. Right: View from within kitchen, out toward entry and servery. Source: DPA Architects. January 2020.

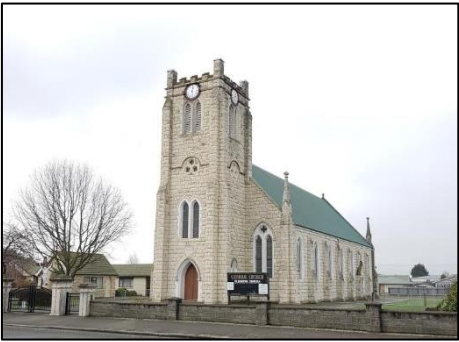
<p>St Joseph's Catholic Church, Temuka</p> <p>Built in 1879-82 with donated limestone from the upper Waitohi district, some 14 miles away. The tower contains bells cast in New York, installed in 1881. Features 31 stained glass lancet windows donated by parishioners. Spire removed following Canterbury earthquake sequence.</p> <p><i>Image: St Joseph's Catholic Church, 23 August 2020.</i> <i>Source:</i> https://sites.rootsweb.com/~nzlscant/StJoseph_Temuka.htm</p>

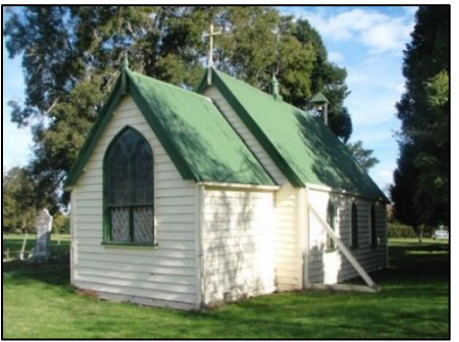
<p>St Anne's Anglican Church, Pleasant Valley</p> <p>Opened 1863. While not stone, this modest timber church in the Gothic style is highly significant as the oldest church of any denomination in South Canterbury and demonstrates the history of the Anglican Diocese in the region. Pit sawn timber and cob interior lining presented in the Gothic revival style.</p> <p><i>Image: St Anne's Church, 4 May 2007. Source:</i> https://www.heritage.org.nz/the-list/details/1993</p>

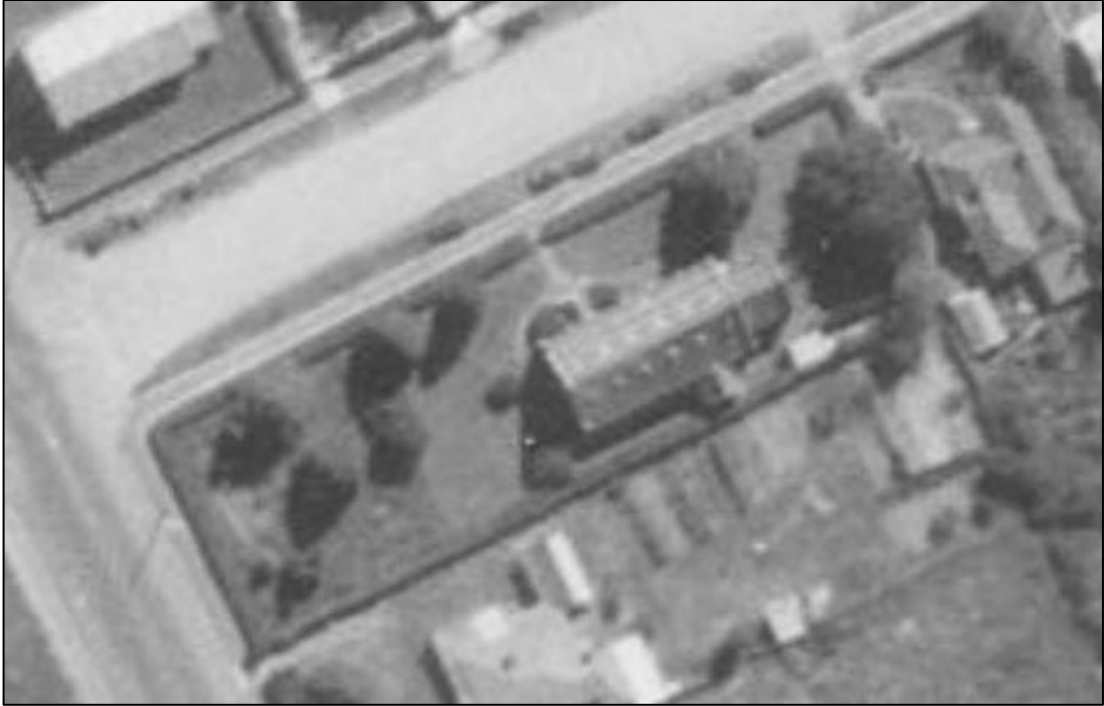
Aerial photograph 26 February 1939 showing original form of church with nave, chancel, entry porch to north elevation and sacristy to south elevation. The six dormer roof vents to the north and south roof planes of the nave are clearly visible. There appears to be an outbuilding to the south of the chancel. The image shows the early fencing treatment with hedging and numerous trees in the allotment. Source: Retrolens Historical Image Resource, SN86.

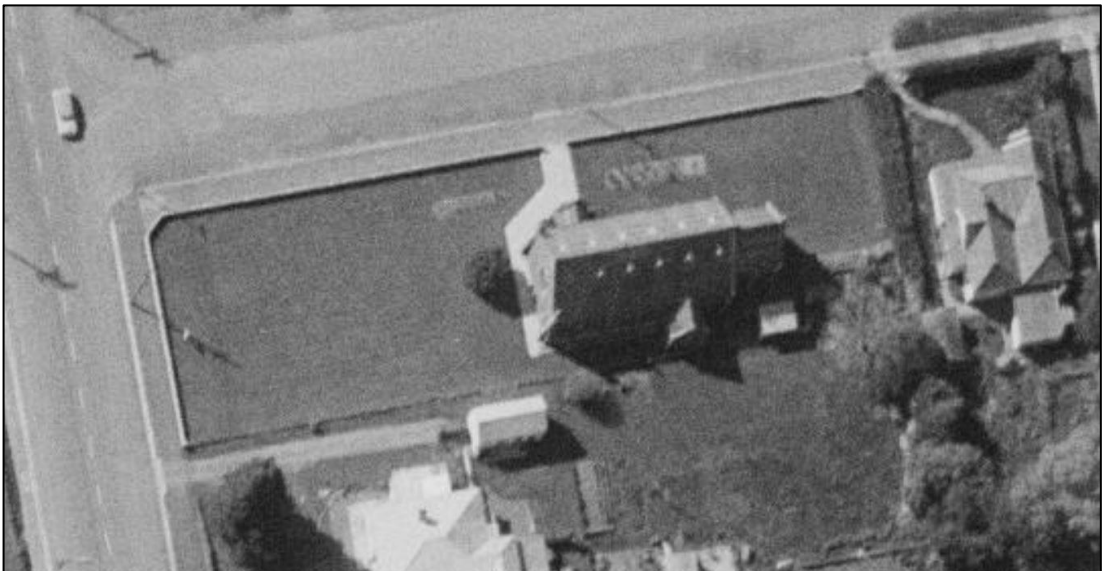
Aerial photograph 9 October 1961 showing St Peter's Church with trees removed and new concrete wall fencing treatment to King and Dyson Streets. A new footpath has also been constructed. Source: Retrolens Historical Image Resource, SN1402.

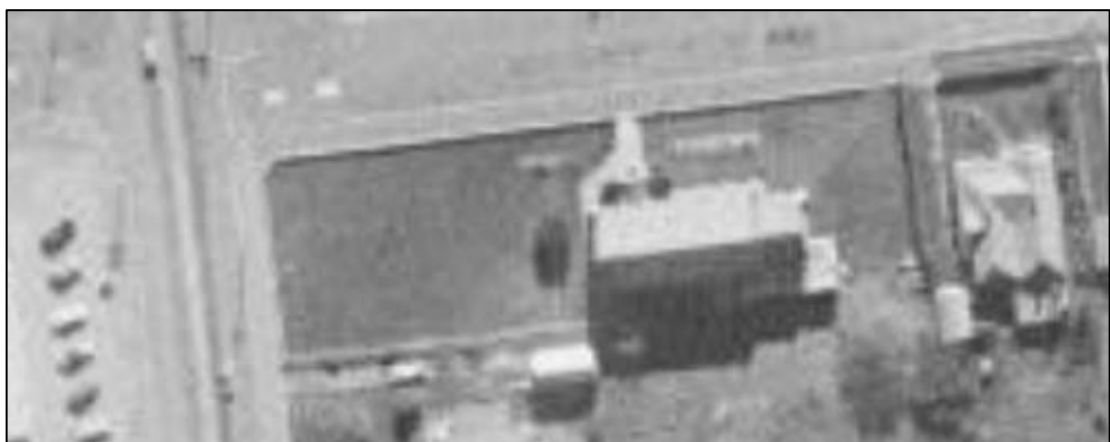
Aerial photograph 19 August 1967 showing completed vestry addition. Source: Retrolens Historical Image Resource, SN1965.

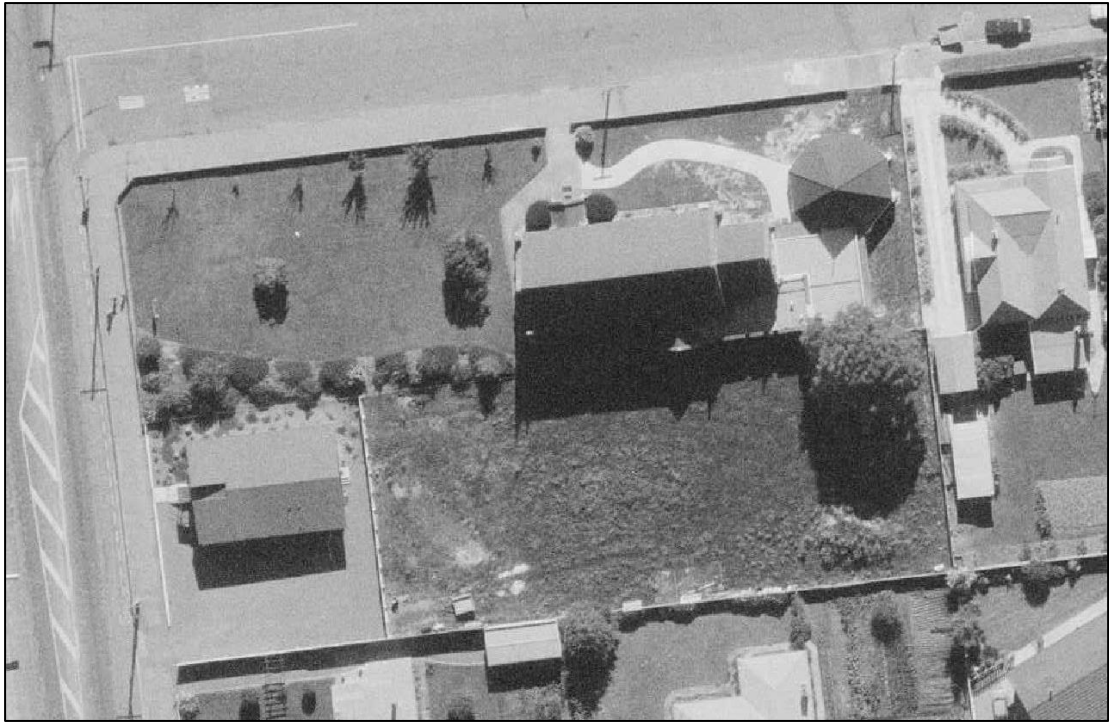
Aerial photograph 15 April 1979 showing new parish centre and landscaping treatment. Source: Retrolens Historical Image Resource, SN5407.

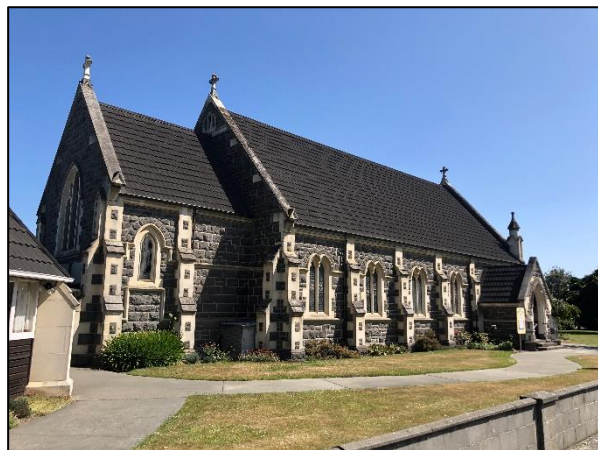
Non-contributory

Parish centre and hall additions (RF)

South Elevation:

The south elevation was extended in 1965 to include the addition of a vestry eastward from the sacristy. It was extended further in 1978 to include the addition of the parish centre. The additions partially obscure the interpretation of nave and sanctuary, nevertheless, the original portion of St Peter's Church's south elevation from the sacristy westward remains in its original form.

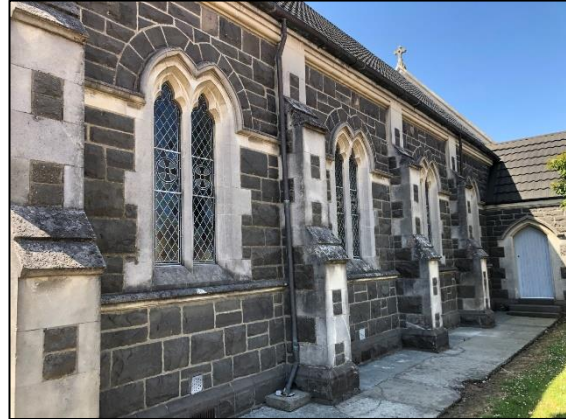
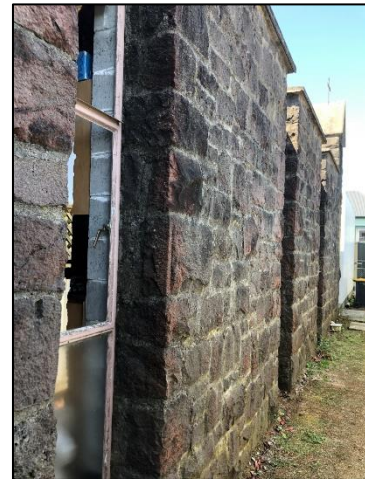
Non-contributory

Concrete wall to Parish centre addition (RF)
 Ventilation grills (RF)

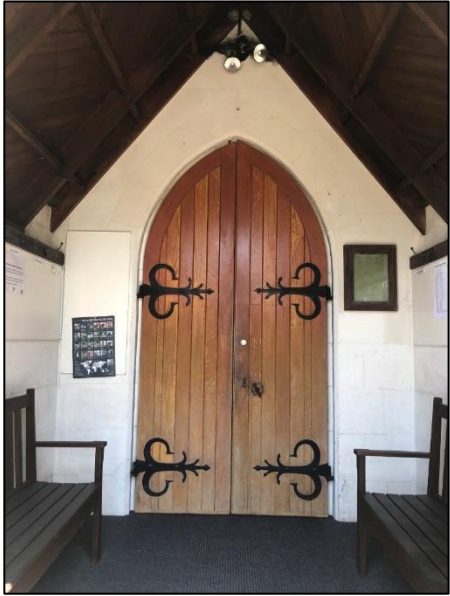
Entry Porch: The entry porch remains largely as originally constructed. Present rating: Exceptional Significance	
Exceptional Limestone walls (OF) Tongue and groove ceiling (OF) Rimu arched door decorative ornate hinges? (OF)

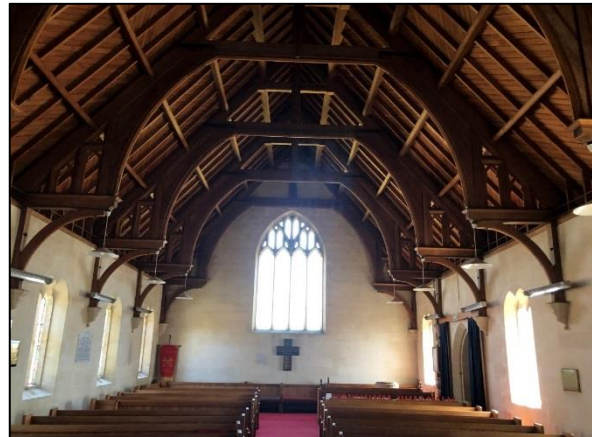
Exceptional

Limestone walls (OF)
 Hammer-beam roof trusses (OF)
 Limestone arched entrance to sanctuary (OF)
 Rimu panelled door to sacristy (OF)
 Pipe organ (OF)
 Limestone Pulpit (OF)
 Arched stained glass window to west wall (OF)
 Brass lectern (*OF)
 Brass book stand (OF)
 Limestone font with marble legs and oak top (*OF)

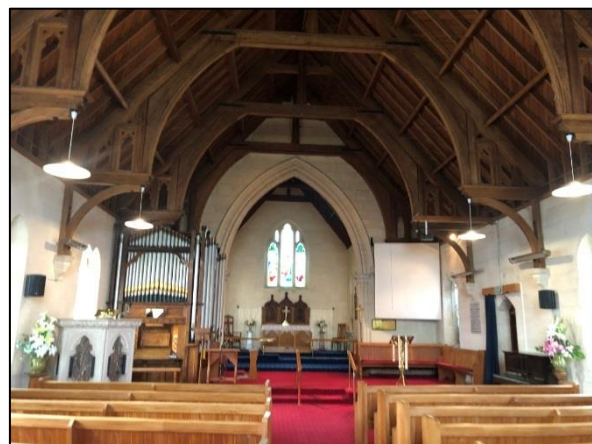
Moderate

Pews (LF/RF)
 Stained oak cross to west wall (LF)
 Brass & Timber Cross to south wall (LF)
 Plaques – various (LF)
 Oak prayer desk to chancel (*LF)

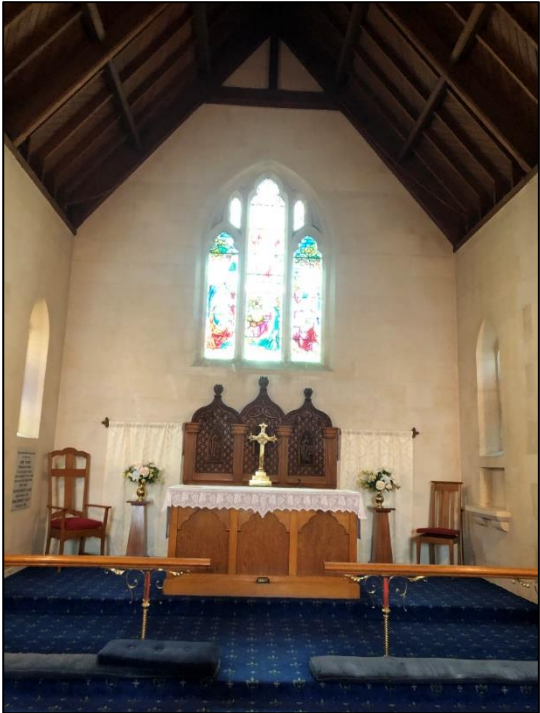
<p>Chancel: Altar rails were added in 1900. The chancel was extended in 1928.</p> <p>Present rating: Exceptional Significance</p>	
<p>Exceptional Limestone walls (OF) Tongue and groove ceiling, trusses, under purlins & rafters (OF/LF) Brass & Oak altar rails (LF) Oak altar (OF) Brass cross (*OF) Rimu reredos (OF) Stained glass windows to north, east and west walls (LF)</p> <p>Considerable Oak Hymn board (*OF)</p> <p>Moderate Marble plaque to John Talbot (LF)</p> <p>Little Oak chairs (*LF) Flower stands with brass vases (*LF) Blue carpets (*LF)</p> <p>Non-contributory</p>

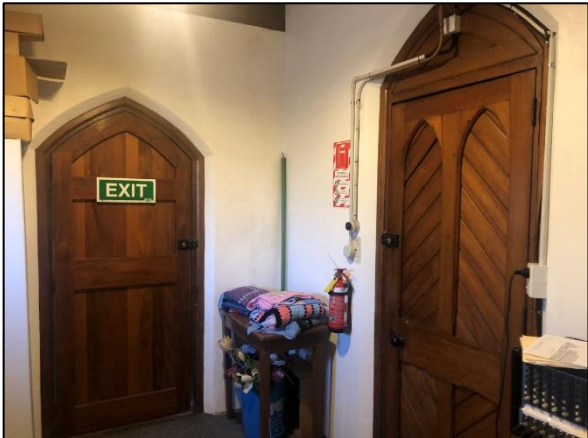
<p>Sacristy: The sacristy has been modified by the provision of a doorway on the east wall which leads to the vestry addition.</p> <p>Present rating: Considerable Significance</p>	
<p>Exceptional Limestone walls (OF) Tongue and groove rimu ceiling (OF) Rimu panelled door to church (OF) Exterior window (OF)</p> <p>Considerable</p> <p>Moderate Rimu panelled exterior door (*LF)</p> <p>Little</p> <p>Non-contributory Carpet tiled floors (*RF) Sink bench & cupboards (LF) Rimu panelled door to vestry (LF)</p> <p>Intrusive Paint to limestone walls (*RF)</p>

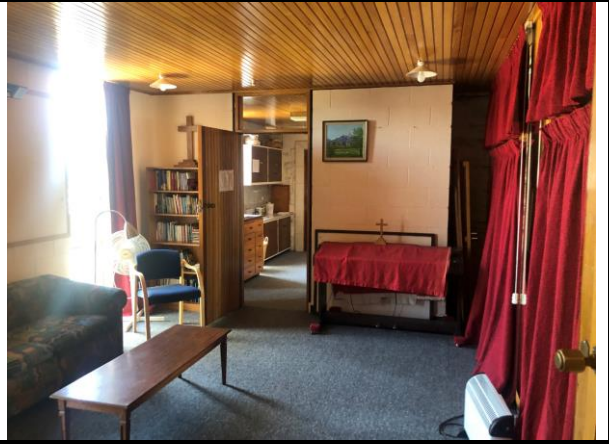
1965 Addition including clergy and choir vestries, W/Cs and Vestibule:Present rating: **Little Significance****Considerable**

Bluestone wall of church visible within clergy vestry (OF)

Concrete block walls (LF)

Tongue and groove doors (LF)

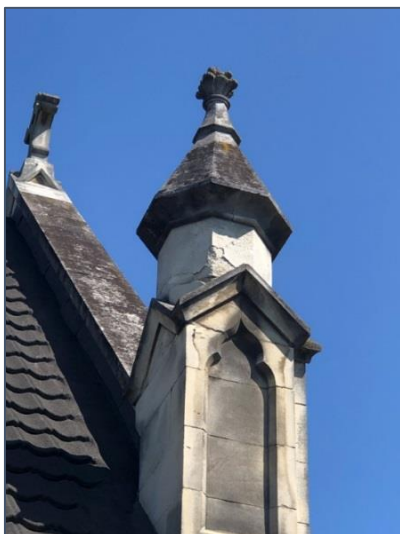
*Weathering and soiling of limestone to pinnacle.
Source: DPA Architects, January 2020.*

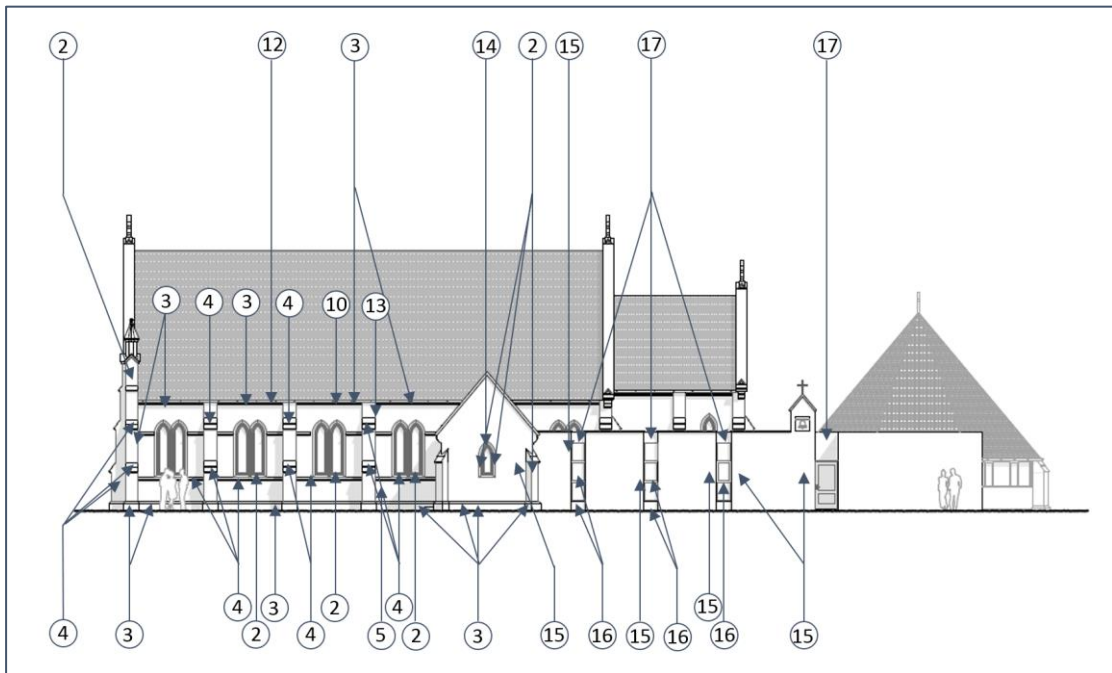
2	Soiling of limestone	3	Mortar weathered or missing
4	Moss growth	5	Exploratory hole drilled into stonework
10	Possible horizontal displacement of stone	13	Minor damage to stone
14	Glass cracked	15	Lichen growth
16	Putty cracked, missing	17	Weathering to stain finish

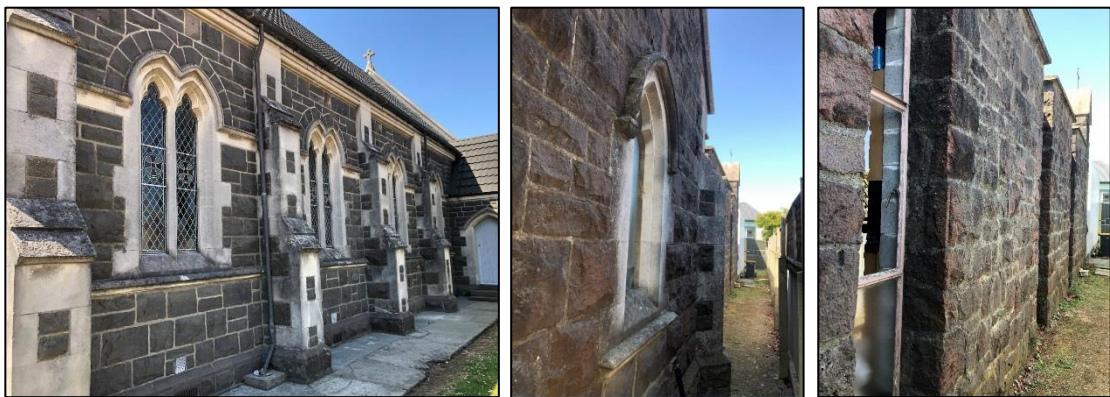
Left and Centre: Soiling of limestone and moss growth. Right: Cracked and missing putty to window joinery and lichen growth to stone. Source: DPA Architects, January 2020.

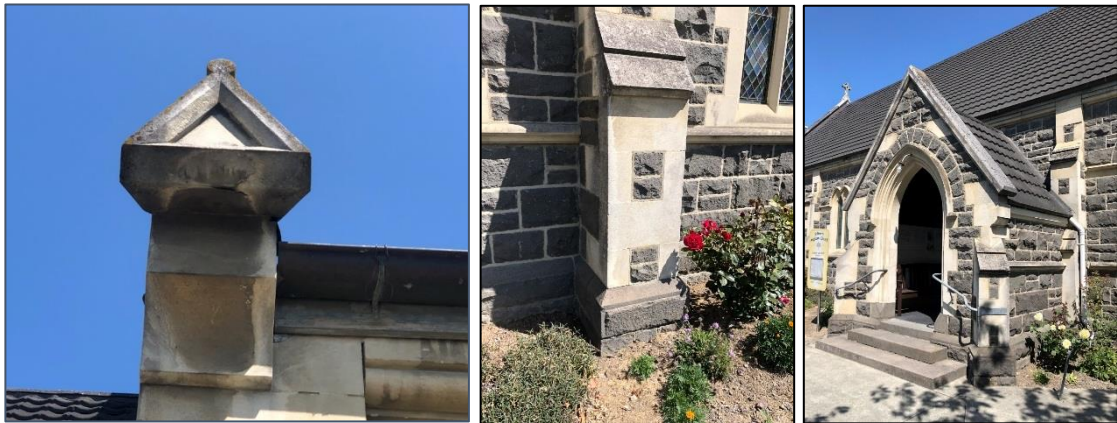
Left: soiling of limestone. Centre: Possible horizontal displacement to stone base of buttress. Right: Handrails and plastic downpipe to entry porch. Source: DPA Architects, January 2020.

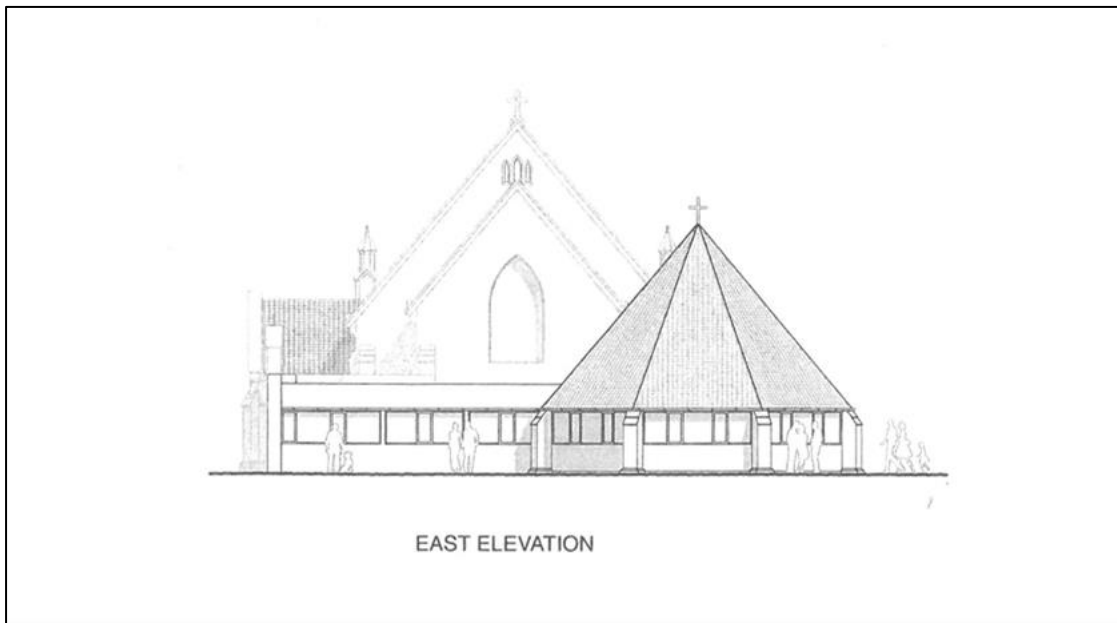
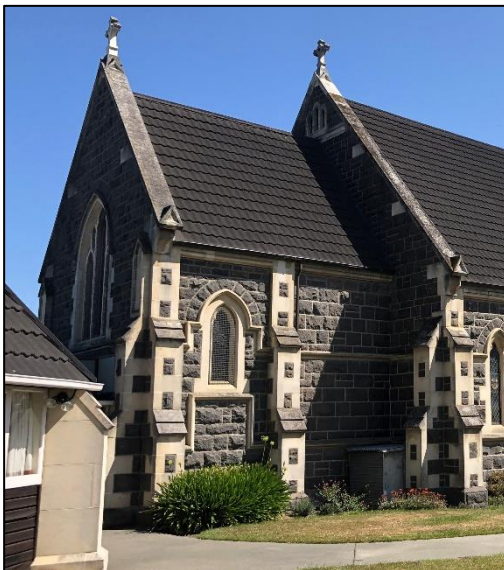
St Peter's eastern gables. Source: DPA Architects, January 2020.

Due to difficulties of access, the condition of the east elevation of St Peter's Church was not able to be ascertained. While there were no apparent areas of concern when the gable ends were viewed from the ground, some of the defects observed on the other elevations might be expected on the east elevation.
