Land Use Consent No. 102.2024.64.1
Land use consents to remediate Peel Forest landfill
Dennistoun Road, Peel Forest

**Decision of Timaru District Council
Land use consent No. 102.2024.64.1**

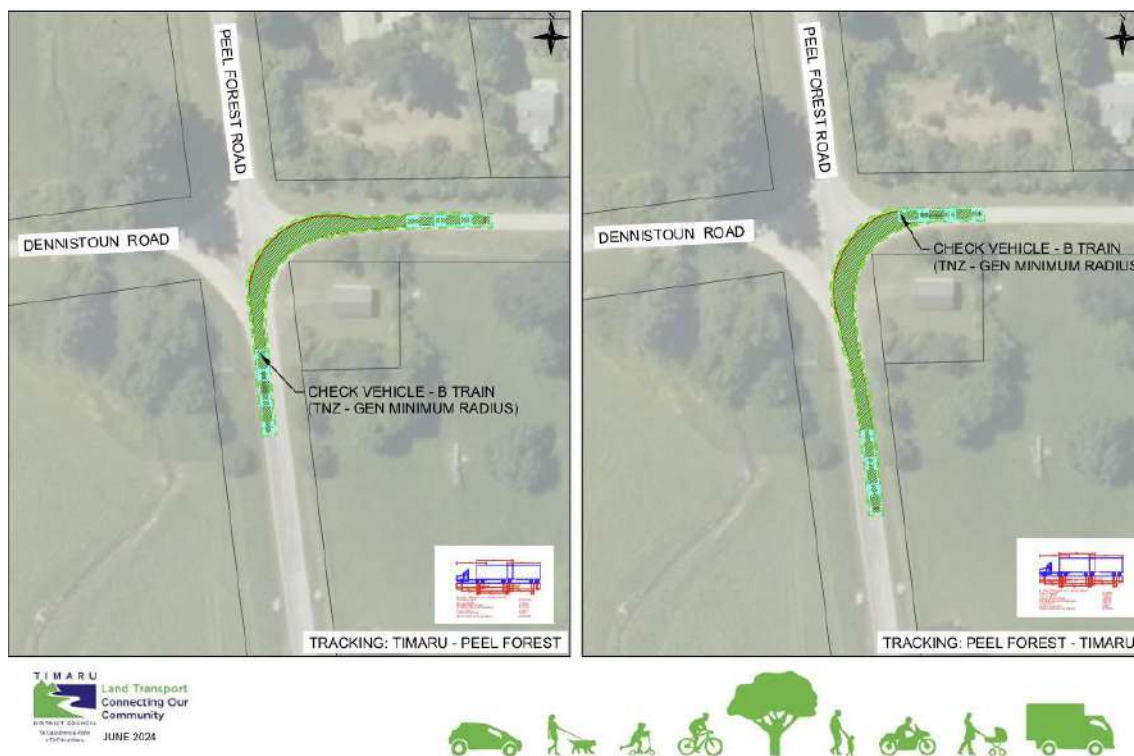
Figure 7: Vehicle tracking diagrams

1. The vehicles will track beyond the existing seal formation making worse the existing evidence of seal edge break; and
2. The truck and trailer units will need to use the entire width of the Peel Forest Road and Dennistoun Road carriageway to successfully negotiate the intersection.

The expert review by Stantec has, consequently, recommended some conditions relating to an upgrade of the intersection, a Construction Traffic Management Plan and signage.

Potentially the most significant issue is the geometry and condition of the intersection of Dennistoun/ Mount Peel Road with heavy vehicle truck and trailer unit movements. Information provided in response to the RFI has been assessed by Stantec in its expert review. Stantec recommend several conditions to manage potential traffic effects. The effects of the change in their local road environment are likely to be minor or more than minor albeit run off a low vehicle volume base and being inserted into a presently benign rural environment.

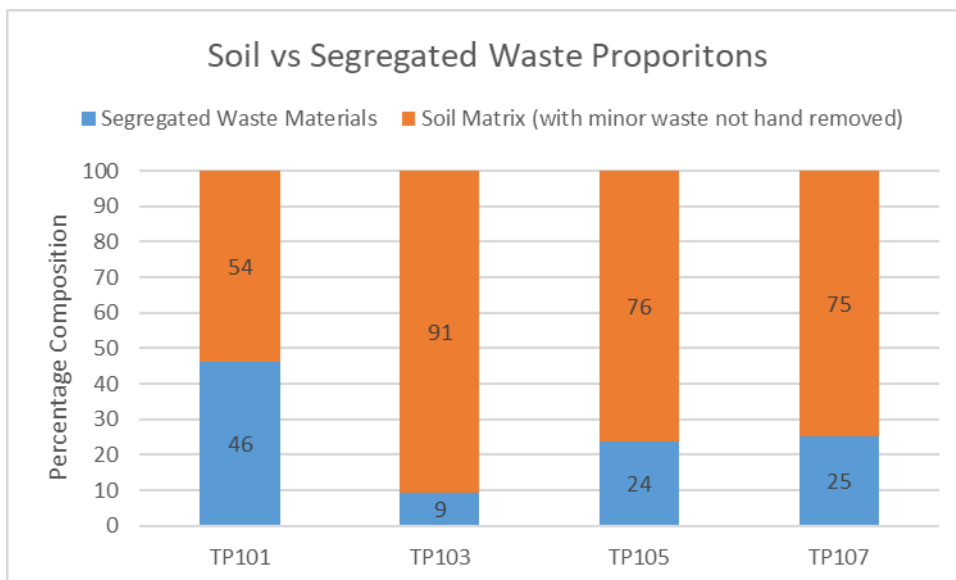
Graph 2: Soil vs Segregated Waste Proportions

A summary of the approximate ratio of soil matrix to waste materials within TP101, TP103, TP105 and TP107 (waste screening test pits) is presented in Graph 2 below. The main soil matrix including fine waste fragments that passed the 25 mm screen, as well as smaller missed fragments not removed during the manual hand picking, comprised 54-91% of test pit arisings. The highest proportion of waste material was encountered in TP101, which is where the highest proportion of ‘Waste Mixture’ was observed. The lowest proportion of waste material was encountered in TP103 where the lowest proportion of ‘Waste Mixture’ was observed and there was a higher proportion of ‘Soil-Waste mix’. This indicates that the manual hand-picking exercise and screening results compare well with test pit observations.

Note: ‘minor waste’ includes fine waste fragments that passed the 25 mm screen as well as smaller and missed fragments not removed during the manual hand picking. Note that TP105 and TP107 encountered natural soils and so had an overall lower proportion of waste. Whilst the majority of the natural soils were separated from the waste, some would have been mixed in the waste materials and will be influencing the above proportions.

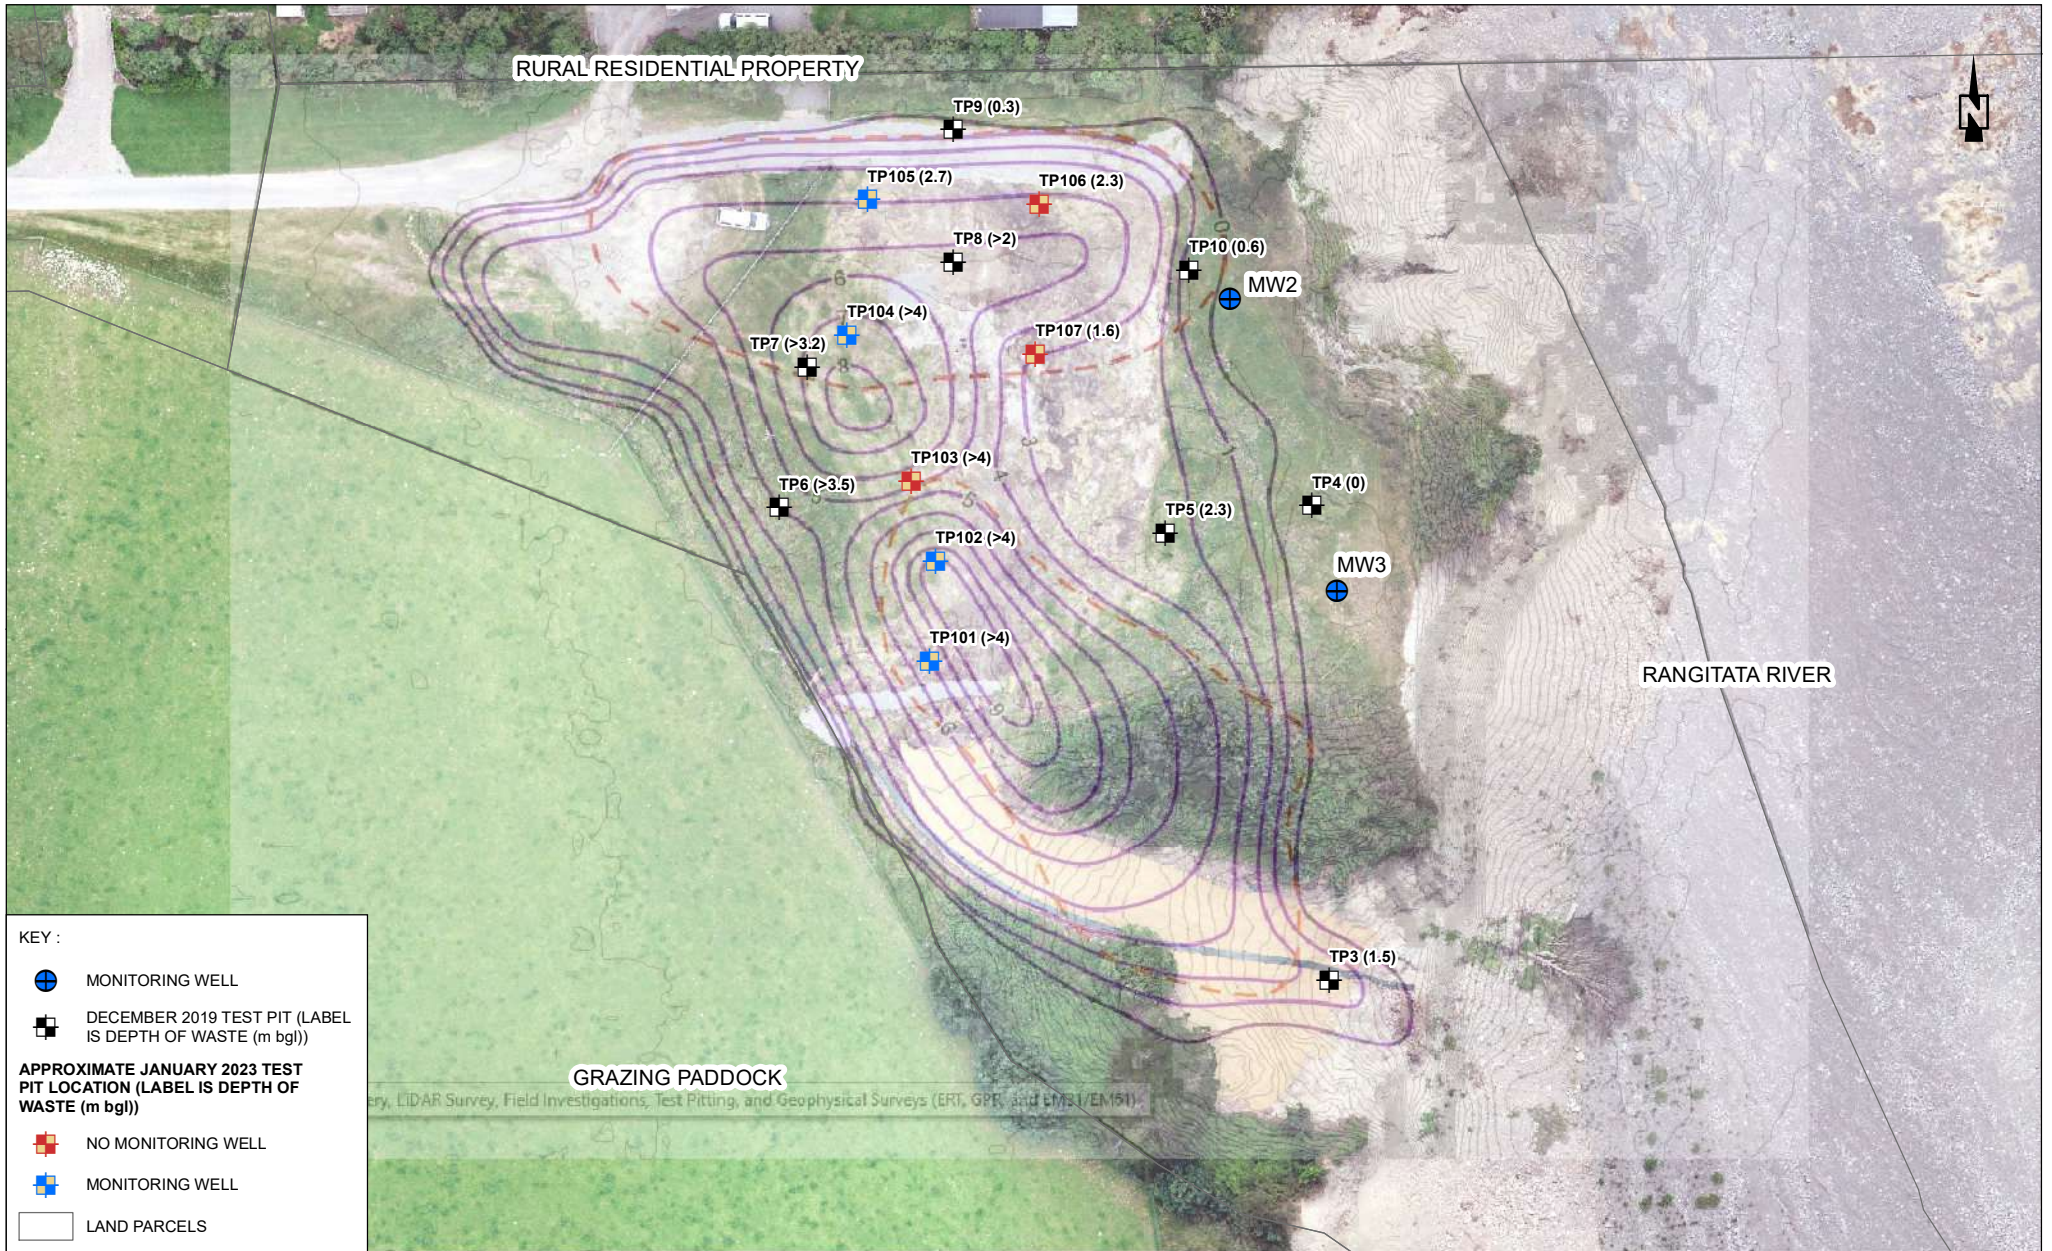
FIGURE 2 : PEEL FOREST LANDFILL INTERPOLATED WASTE THICKNESS

SOURCE:
 1. UAV IMAGERY FLOWN BY PATTLE DELAMORE PARTNERS LIMITED DECEMBER 2022 (<2 M ACCURACY).
 2. CADASTRAL INFORMATION AND INSET SOURCED FROM THE LINZ DATA SERVICE <https://data.linz.govt.nz/> AND LICENSED FOR RE-USE UNDER THE CREATIVE COMMONS ATTRIBUTION 4.0 LICENSE.
 3. DEPTH OF WASTE CONTOURS 9m bgl) INTERPRETED FROM AERIAL IMAGERY, LIDAR SURVEY, FIELD INVESTIGATIONS, TEST PITTING AND GEOPHYSICAL SURVEY

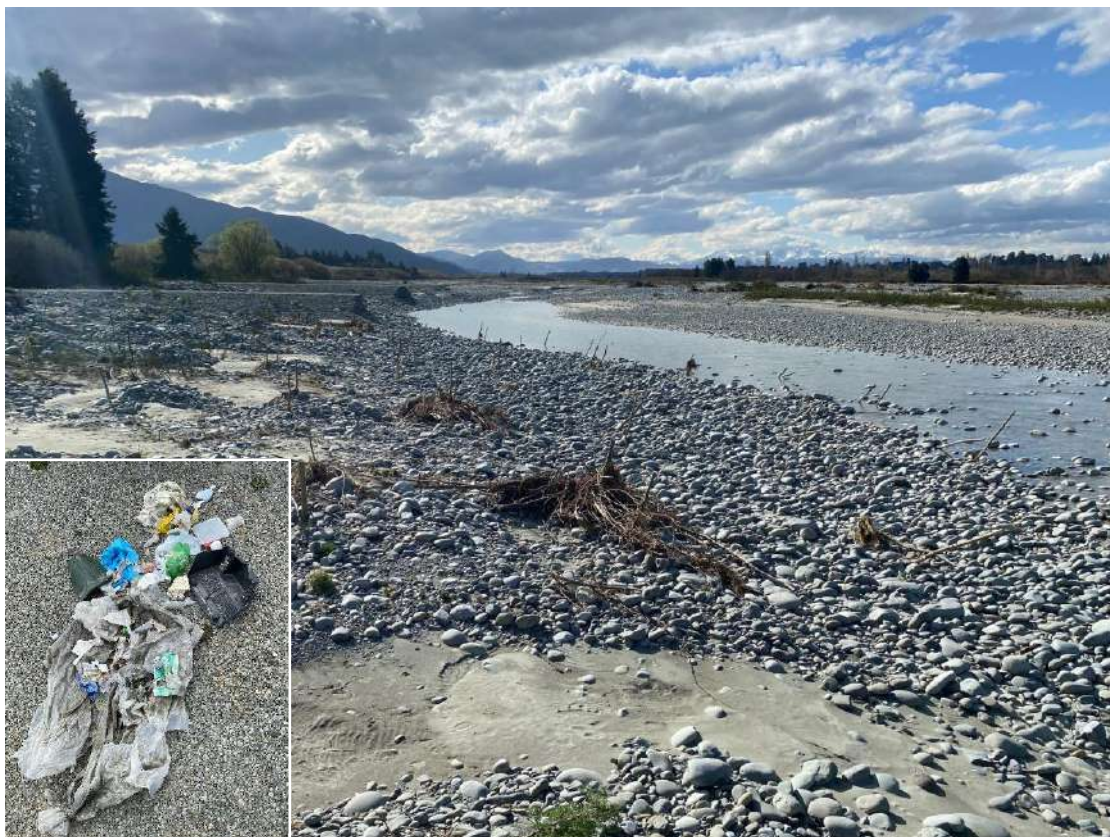
Photograph 2: View looking north west during Rangitata River Bed inspection downstream of the landfill following flood event. Inset shows waste collected from survey area. (September 2022)

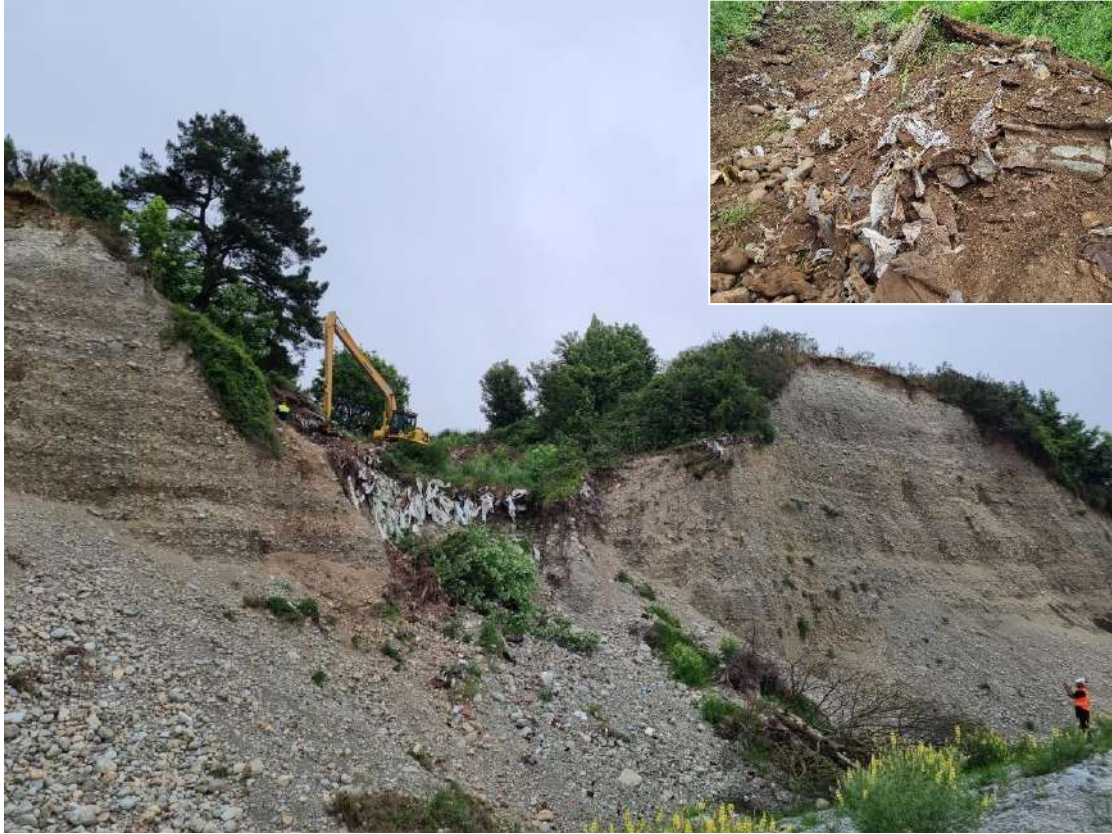
Photograph 3: View looking north west from Rangitata River Bed inspection towards gully during interim remedial works. Waste materials can be seen to have fallen into the toe of the terrace. Inset shows waste materials encountered. (December 2022)

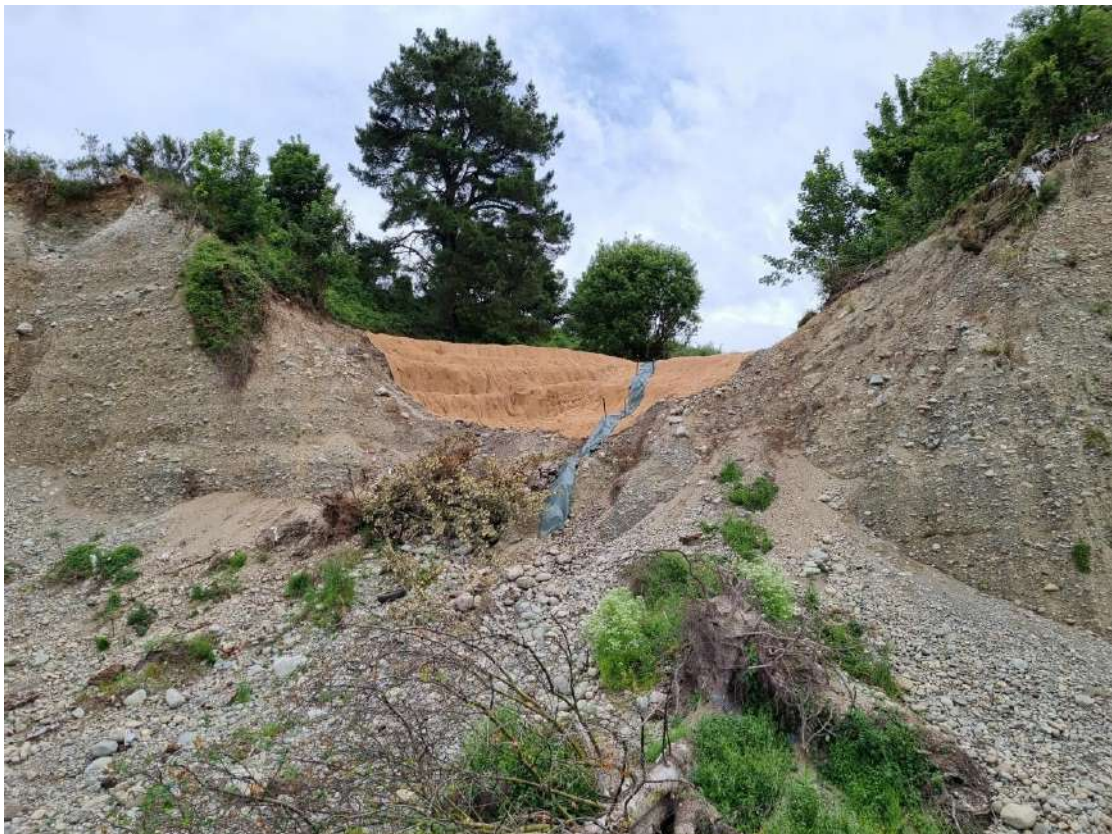
Photograph 4: View looking west from Rangitata River Bed towards gully following interim remedial works. BioCoir coconut matting and Flexiflume piping visible. (December 2022)

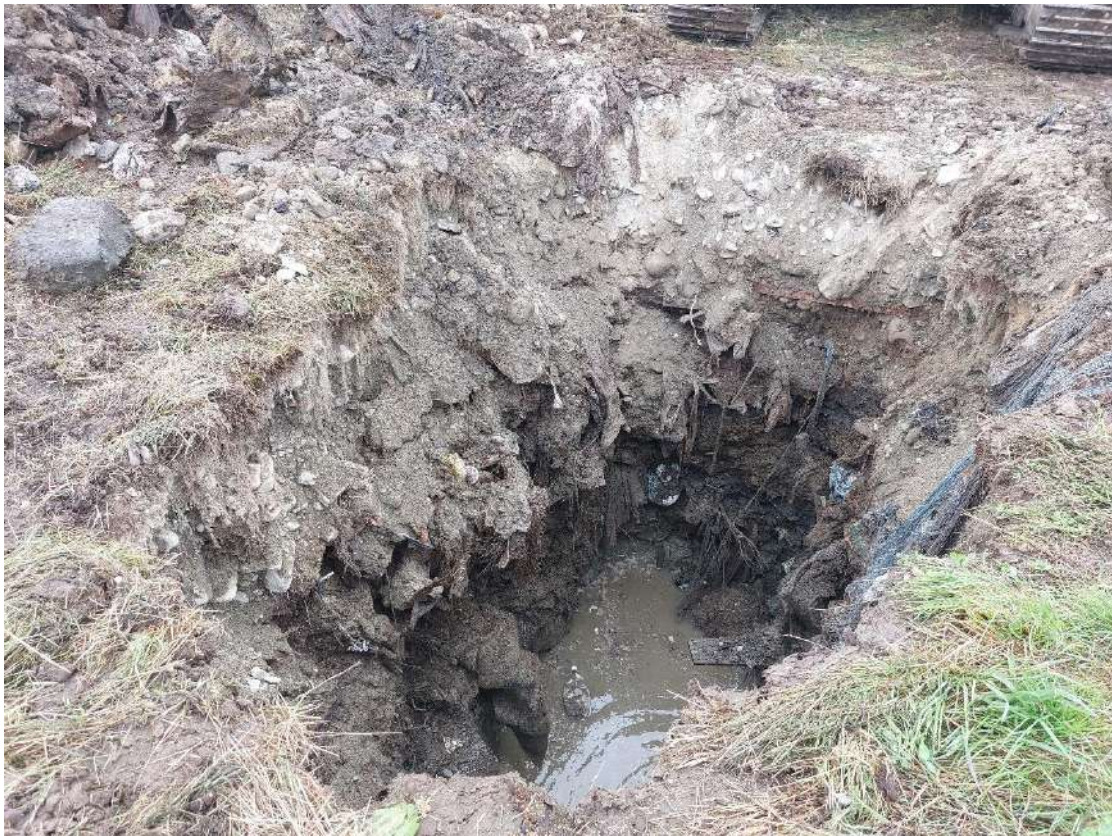
Photograph 24: TP104 excavation. Perched groundwater can be seen at the base.

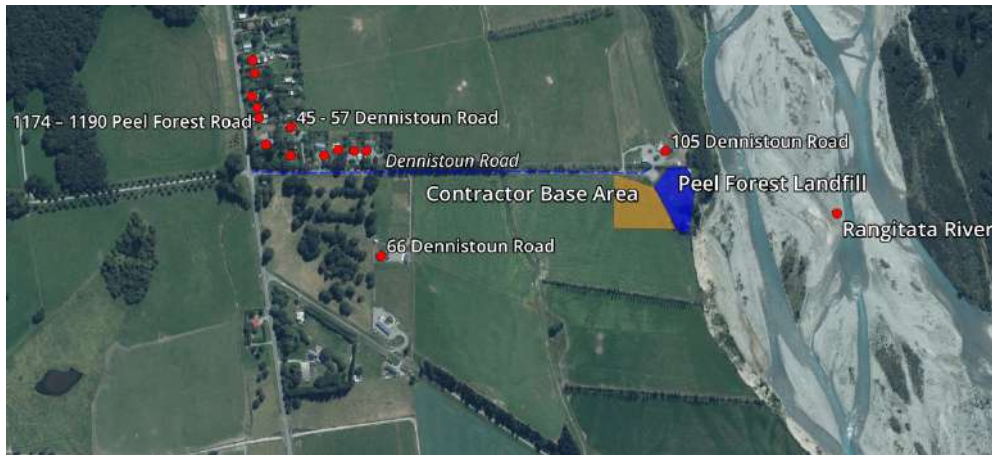
Figure 2: Map of sensitive receptors within 250 of dust sources

Figure 2 shows potentially sensitive receptors that are located within 250 m of dust sources (i.e. the landfill site, the contractor base area and the unsealed portion of Dennistoun Road). Table 1 identifies the type and location of potentially sensitive receptors, which source of dust is likely to cause the largest impact and the distance between source and receptor.
