**BEFORE THE HEARINGS PANEL  
FOR THE PROPOSED TIMARU DISTRICT PLAN**

**STATEMENT OF EVIDENCE OF MICHAEL BOSCHEN ON BEHALF OF THE  
CANTERBURY REGIONAL COUNCIL**

**Ecosystems and Biodiversity, Natural Character and Natural Features and  
Landscapes Chapters**

**25 October 2024**

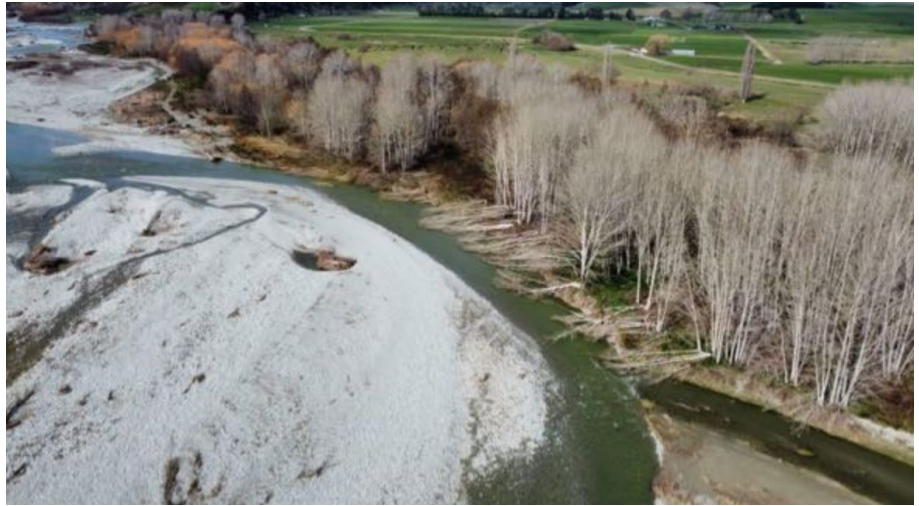
*Figure 1: Aerial image of completed layering where poplars are partly cut and pushed over to stabilise an erosion site.*

- b. Where there are active erosion sites that need to be stabilised before the erosion continues into the stopbank, which is the last line of flood defence in this system. The preferred approach is to use nearby large trees' to be 'tied-in' to the erosion site (anchored tree protection) or to 'layer' trees that are on the edge of the erosion site (see figure 1 as an example of layering). This creates a short-term physical barrier to worsening erosion, and if willow plants are used, the tree will continue to grow and establish a strong mat of roots providing long-term stabilisation.

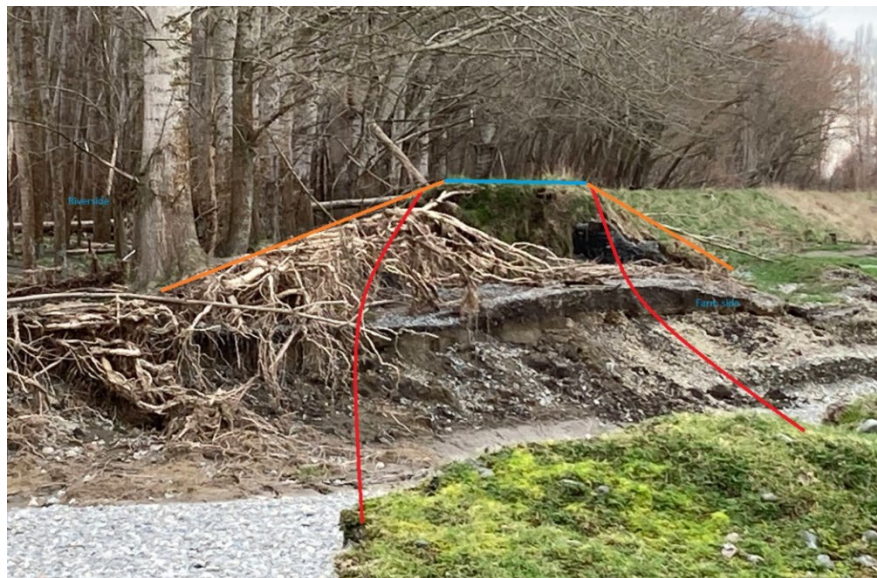
*Figure 2: Section of washed out stopbank. The longitudinal crest followed the red lines, and the stopbank profile is shown by orange and blue.*

- c. The tree is growing in, or within 5 metres of a stopbank and risks stopbank integrity. Historic plantings, or wild-growing trees may be within 5 metres of stopbanks and, as risk assessment determines the need, are methodically removed. Large tree roots that penetrate deep into a stopbank can create weaknesses that compromise the stopbank integrity during flood events. These roots may cause slipping or slumping of the banks as well as internal preferential flow paths. Figure 2 illustrates a section of stopbank that failed during the 2021 Ashburton floods. Whilst the failure in this situation cannot solely be attributed to the tree roots through the stopbank (the river was overtopping), the image does illustrate how far roots can penetrate through the bank.

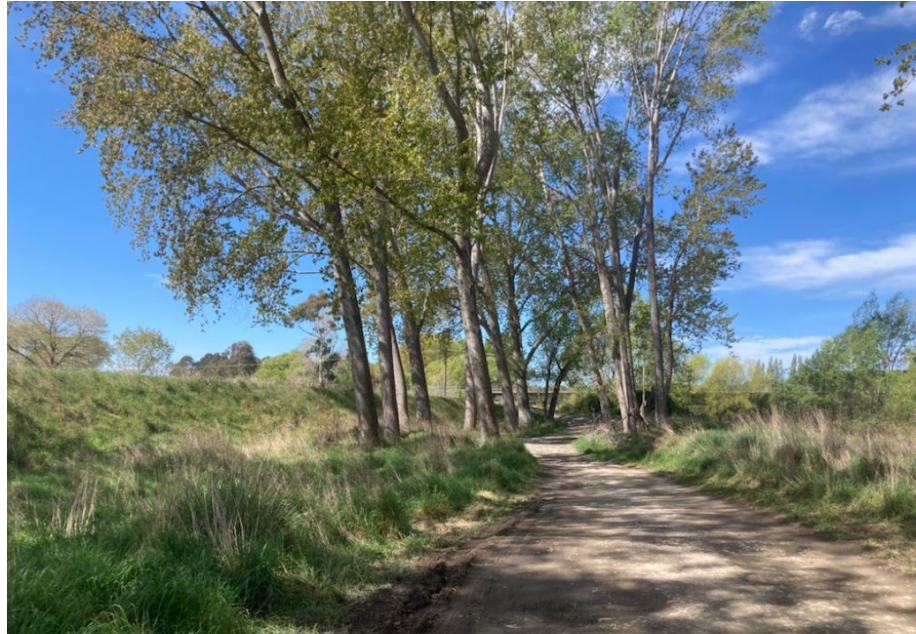
*Figure 3: Current large trees that pose a risk to a stopbank (left) and access (centre-right).*

- 10 The trees in the image below (Figure 3) are larger than the limits provided in the existing Rule ECO-R4 PER 2 and have recently been identified as posing an increased risk to the stopbank or access if they are blown over during a storm. These provide a current example where trees have grown to a size or shape where they are susceptible to storm damage and pre-emptive tree clearance would ensure the safety of the stopbank and flood protection scheme, track users and staff.
