IN THE MATTER OF hearing of the submissions and further
submissions on the proposed Timaru
District Plan: Hearing D – Open Spaces,
Hazards and Risk and Natural
Environment.

**STATEMENT OF EVIDENCE OF TONY MCCORMICK ON BEHALF OF
RANGITATA DIVERSION RACE MANAGEMENT LIMITED**

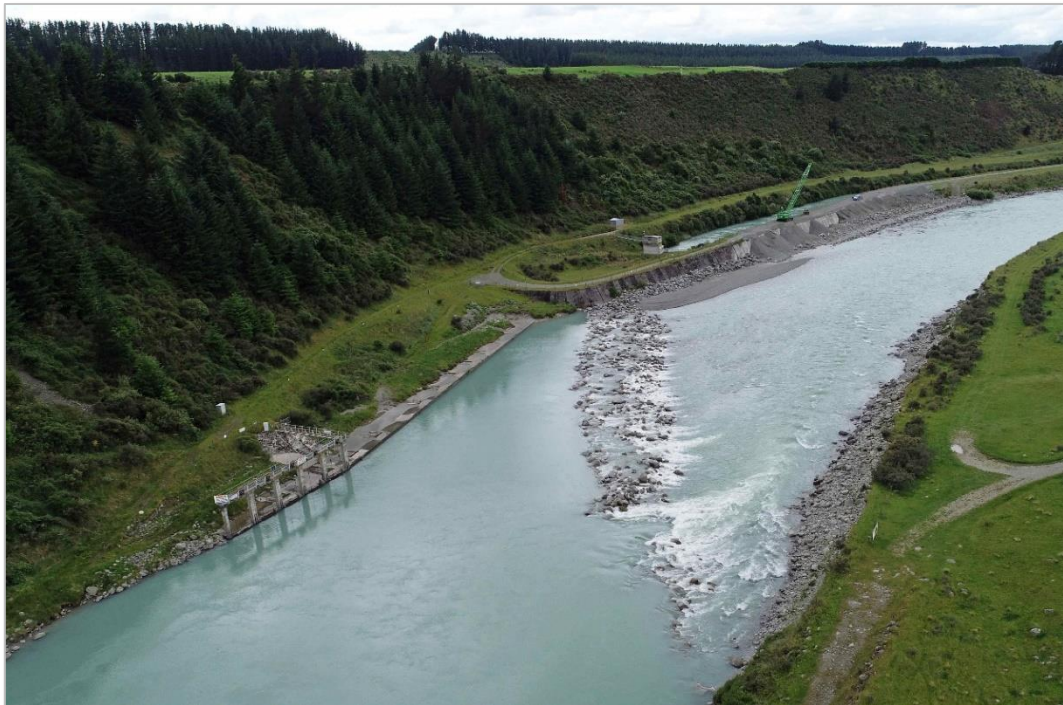
Fig 1: Aerial view looking downstream of the Scheme's intake at Klondyke. The intake is on the left bank under the six concrete pillars. The Scheme's canal can be seen running parallel to the river approximately 150m downstream of the intake. The rock weir is clearly visible, extending across the river with the

navigable 'gap' located approximately two-thirds of the way across. In this illustration, the weir is in need of some maintenance.

10. The main intake at Klondyke diverts part of the river flow into the Scheme's canal through a robust concrete structure on the left/north bank of the river. To be able to operate over the wide range of river flows, the intake facility includes a level control weir that extends across the full width of the river. This weir is constructed entirely from rocks and gravels from within the riverbed. Towards the right/southern side of the weir, a gap in the weir provides a navigable channel for fish and recreational river users such as kayakers and rafters.
11. The following two pictures illustrate the Scheme's intake and the rock weir.

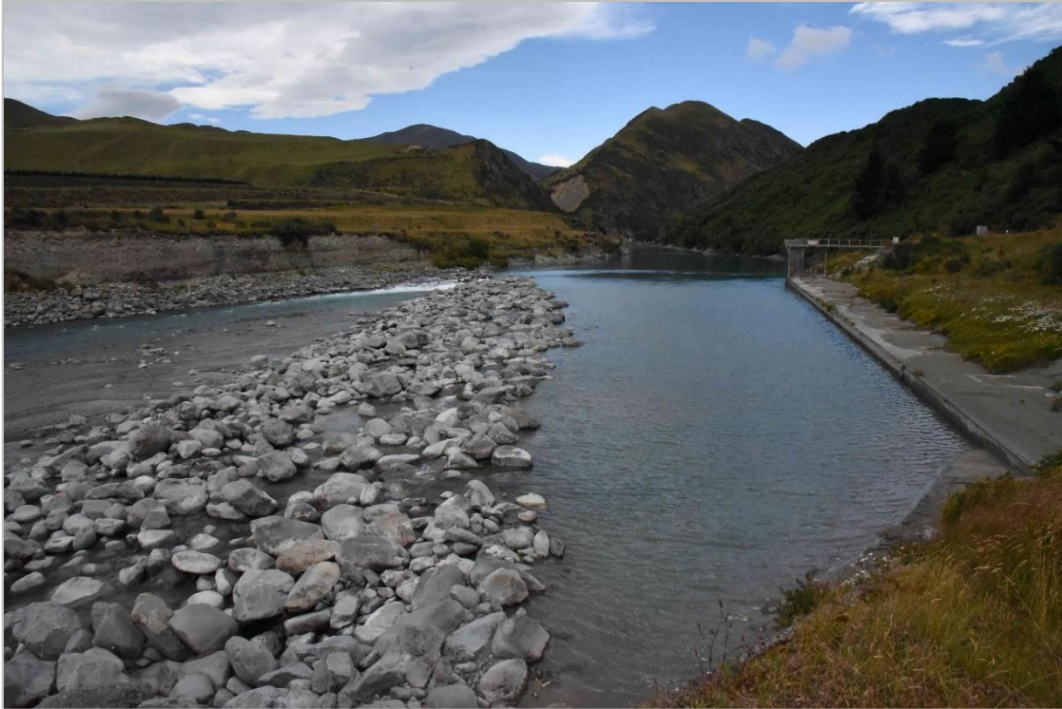
Fig 2 This photo is taken at river level looking out across the rock weir. The intake structure is on the right of the picture. The level control function of the weir is evident – the water level behind the weir is higher than below it – and the navigable gap can be seen towards the far side of the weir. In this illustration, the weir has been recently maintained.

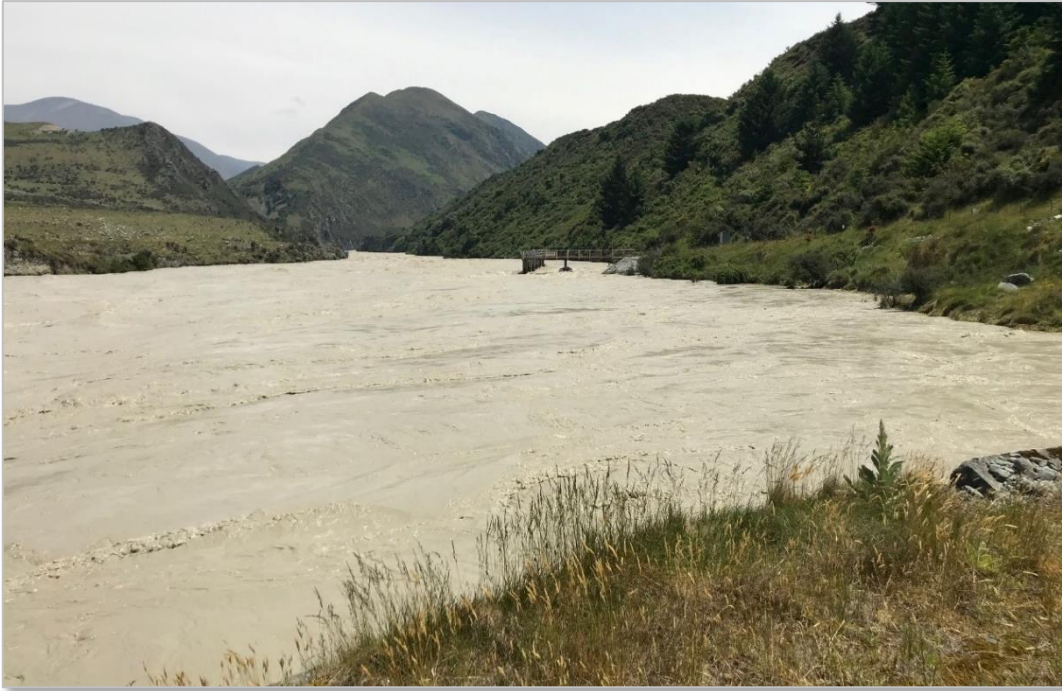
Fig 3 View of the Rangitata River in flood (Dec 2009). The rock weir is fully submerged and approximately 65% of the weir was eroded by this event.

12. The weir is intended to be 'fusible', meaning that when the river is in flood, a significant amount of the weir will be washed away to provide an unrestricted flow path for the flood waters. The last major flood, in December 2019, washed out approximately 65% of the weir. If the weir is eroded by a flood event, we wait until the river flow has receded enough to enable safe access with heavy machinery to the riverbed and rebuild the weir by reinstating dislodged rocks and infilling with gravel.

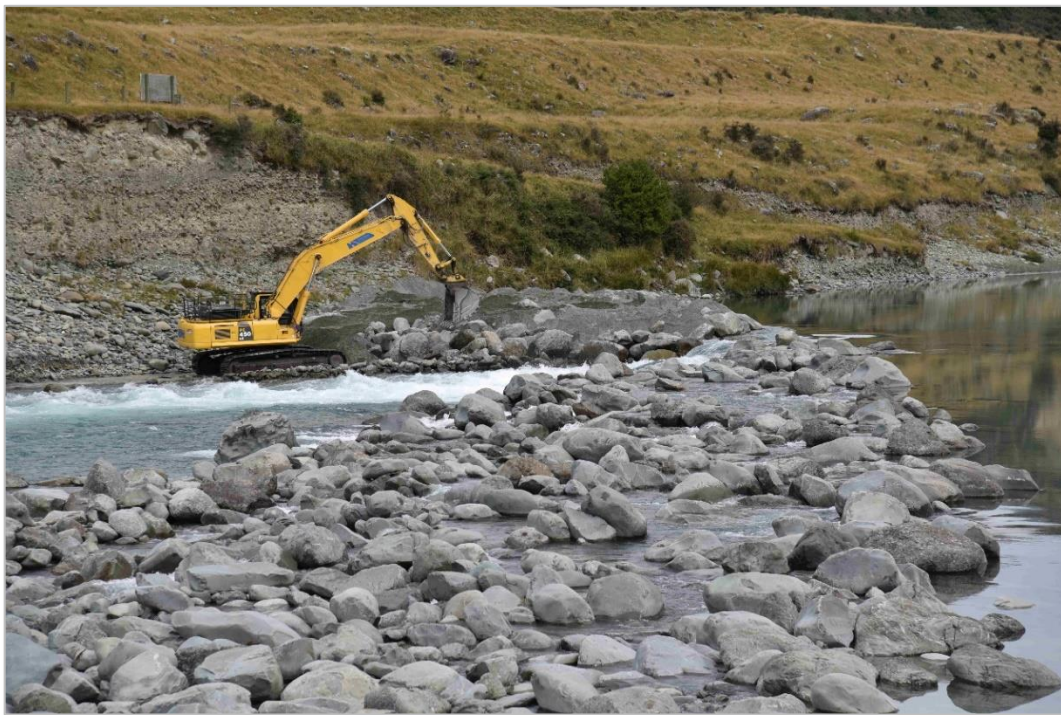
Fig 4 An excavator replacing rocks onto the right abutment of the rock weir.

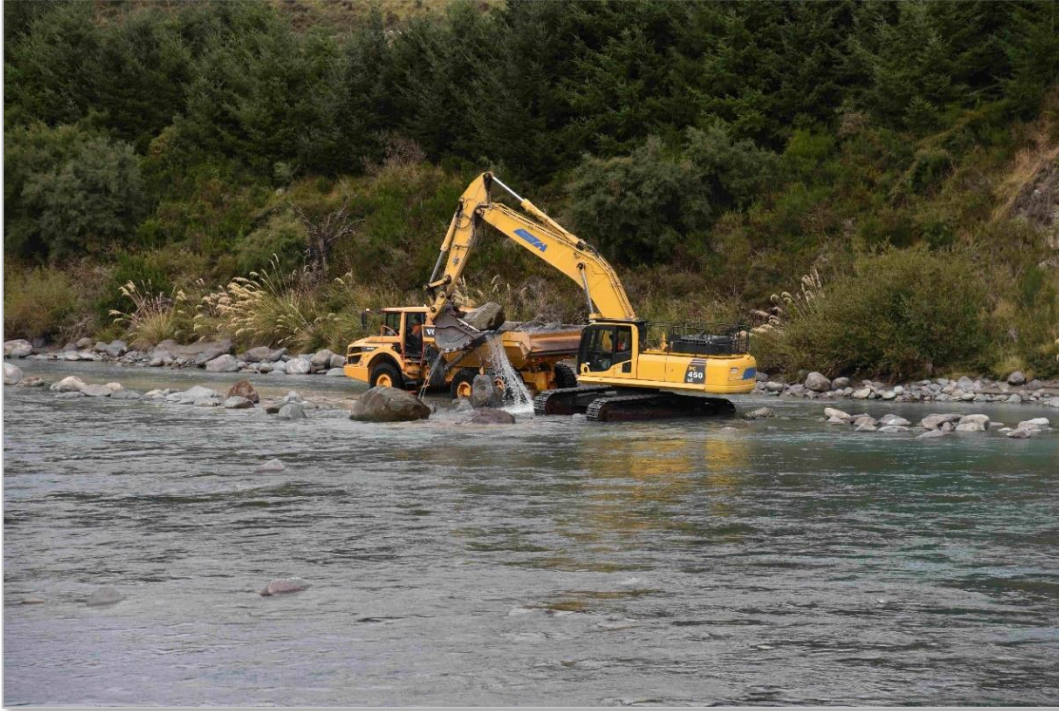
Fig 5 Recovering large rocks downstream of the rock weir to be re-placed on the weir.
